MLC RETAIL REDEVELOPMENT STAGE 2

Drawing name STAIR 18 STONE WORKS SHEET 2

Drawing name STAIR 11/12 STONE WORKS -SHEET 3

Drawing name STAIR 4 STONE WORKS — SHEET 3

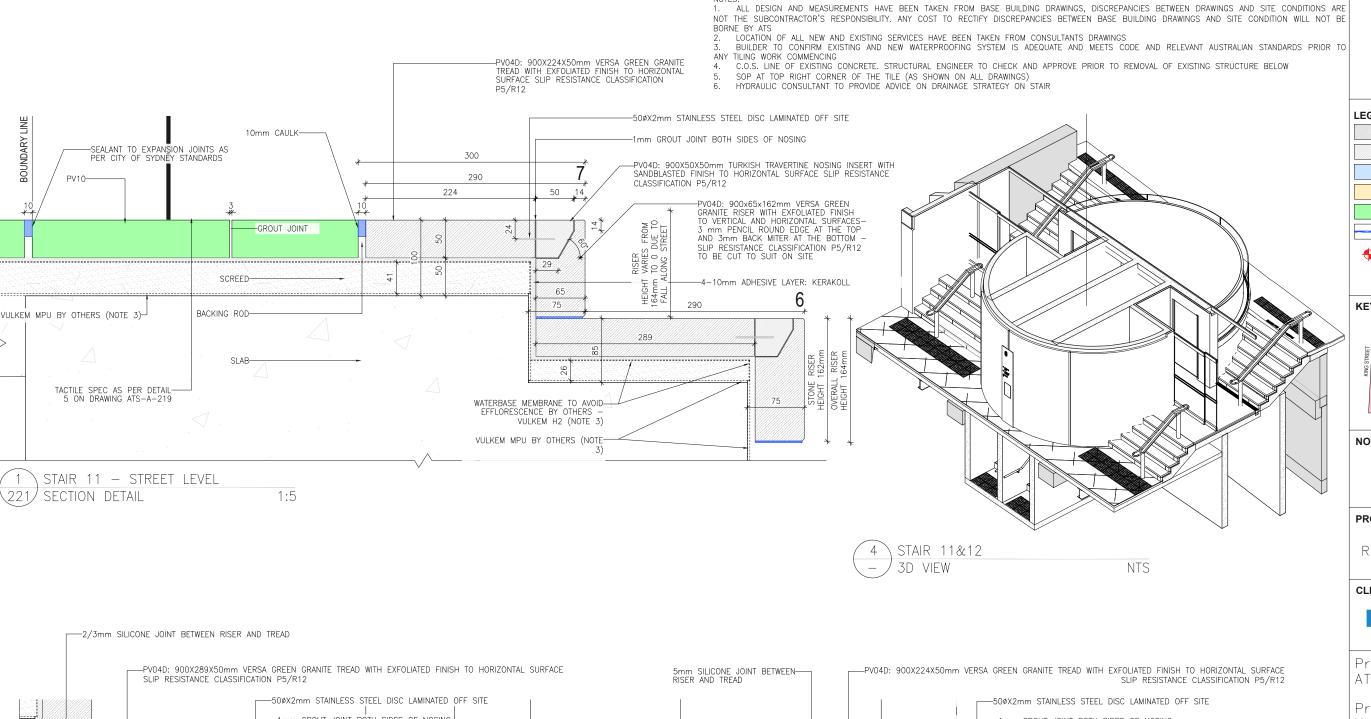
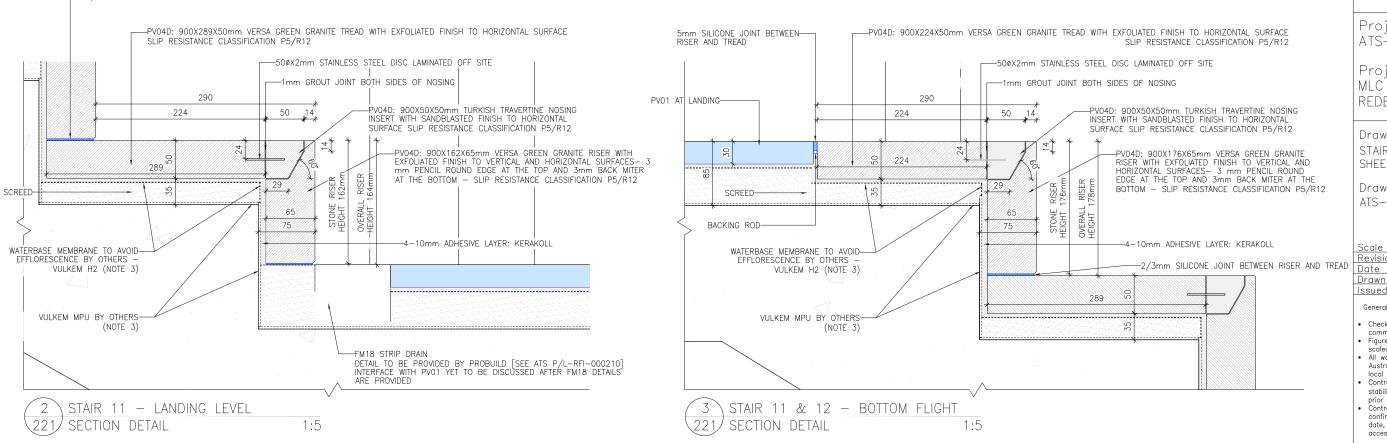
Drawing number ATS-A-234

50mm/65mm EXFOLIATED VERSA GREEN GRANITE TREADS AND RISERS 50mm SANDBLASTED TURKISH TRAVERTINE NOSING PV01 900x900x30 FLAMED VERSA GREEN GRANITE

VERSA GREEN GRANITE
TL03 1200X600X20 UNFILLED/HONED
200 TURKISH TRAVERTINE
AUSTRAL BLACK TO FOLLOW COS

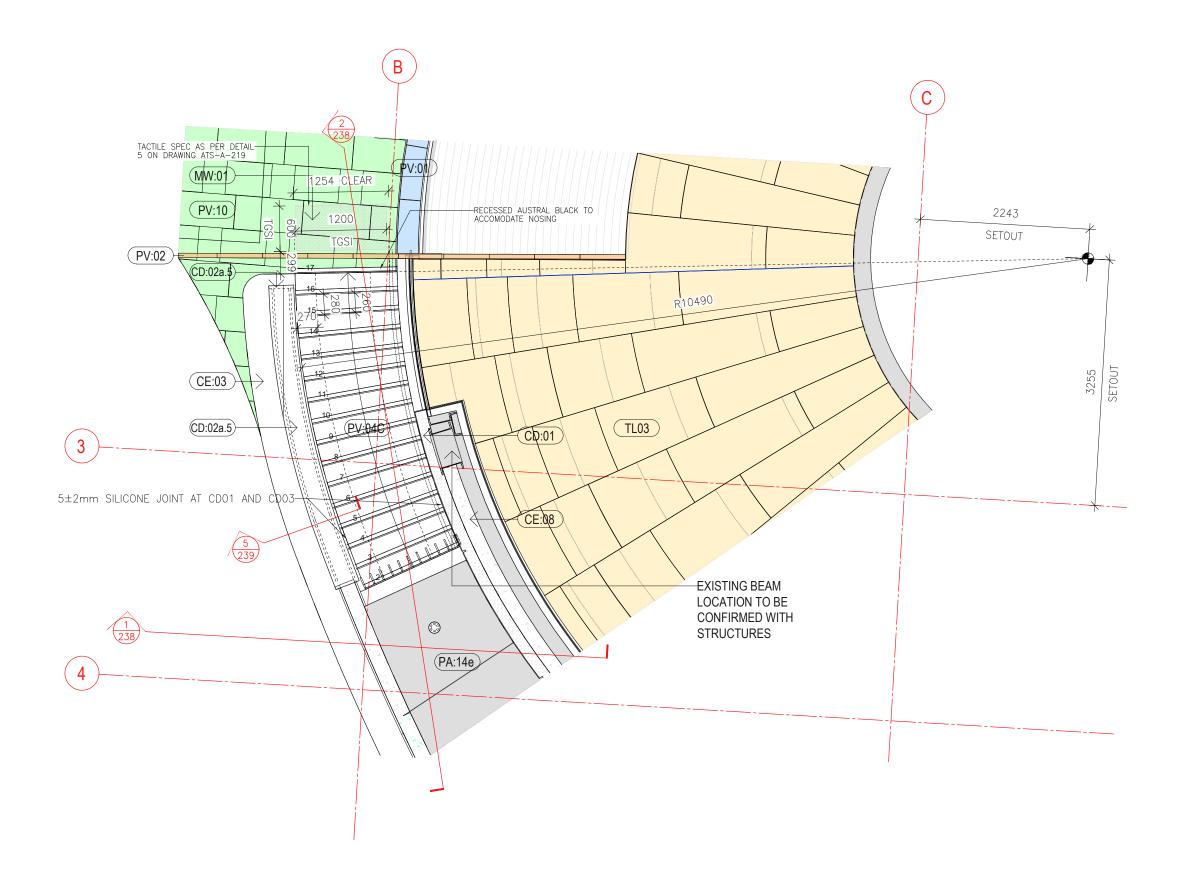
Drawing number ATS-A-237

30mm/40mm EXFOLIATED VERSA GREEN GRANITE TREADS AND RISERS 30mm SANDBLASTED TURKISH TRAVERTINE NOSING PV01 900x900x30 FLAMED VERSA GREEN GRANITE

PV02 600X60X30 UNFILLED/BRUSHED TURKISH TRAVERTINE PV10 50mm EXFOLIATED GRANITE AUSTRAL BLACK

TL03 20mm CUSTOM SIZE UNFILLED /HONED 200 TURKISH TRAVERTINE

CD:03 900x900x40 EXFOLIATED VERSA GREEN GRANITE
